# VersrTile

# Vinyl-Coated Fabric to Roof Tile Recycling Project 2018

# **Executive Summary**

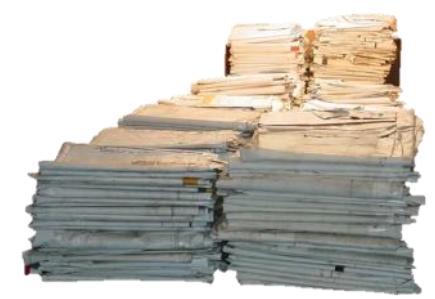
Collected waste billboards

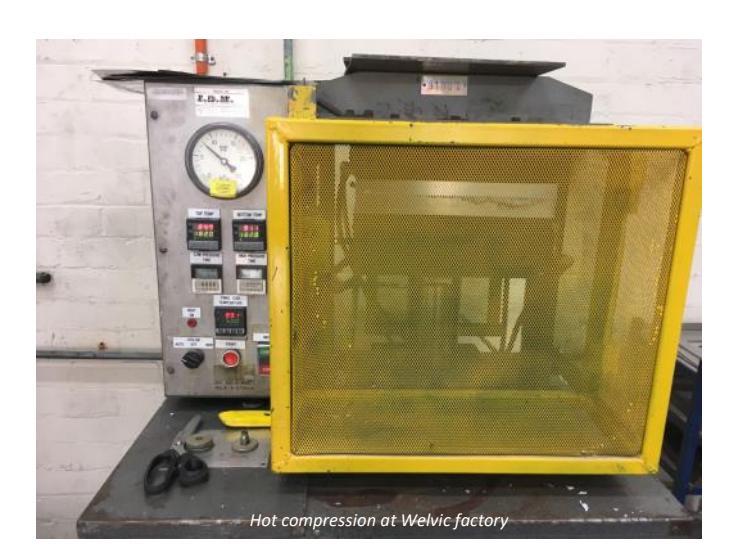
This project confirmed that the reprocessed material can be effectively molded into a complex form with appropriate finishes. Tile detail was improved through the molding process by improving the design of the soft tools. The team trialed different reprocessing methods, from shredding and granulation to cutting strips of fabric for extrusion, producing different fibre lengths. The greatest influence these had was found to be the speed of manufacturing, and shredding and extruding into the molds was found to be the fastest process.
